Propagation Mechanism and Metallurgical Characterization of First Bond Brittle Heel Cracks in AlSi Wire

Raymond T. Fitzsimmons
Raytheon Company
528 Boston Post Road
Sudbury, MA 01776

ABSTRACT

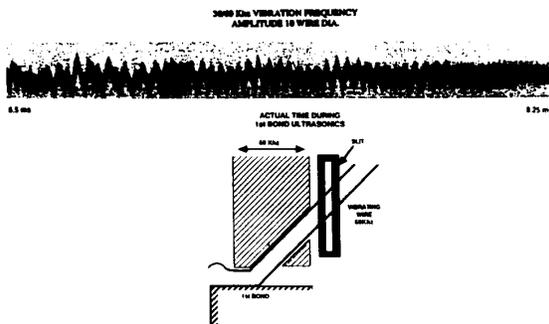
Bottom heel cracks occur only sporadically, but when they are observed, they occur in significant numbers. Observation of the hard wire showed that the cracks are formed during the first bond. The actual vibration of the wire behind the tool during first bond has been photographed using an electronic camera in the streak mode (1). Figure 11 shows the vibration to be approximately 10 wire diameters in amplitude and at frequencies varying from 30 to 60 KHz. This vibration is forced vibration and not resonant vibration because the distance between the tool and the clamps can vary, yet the same number of cracks will occur. It was observed that the cracks also were formed with the clamps open.

Fig. 11. Vibration on wire at the heel of the first bond during ultrasonics of the first bond.

A simple explanation of the mechanism is that the vibrating wire is pinned at the heel of the first bond creating a fulcrum for the work hardening to start to propagate the cracks. The fractured area (after wire pull) always has a line in the middle of the surface. This is the part of the wire ("hinge") that does not move during wire vibration and that fractures by a shear stress mechanism. The line is always horizontal because the motion of the wire is vertical and it is not allowed to move side to side
