# Brittle Cracks Induced in AlSi Wire by the Ultrasonic Bonding Tool Vibration

Raymond T. Fitzsimmons and C. E. Miller

**Abstract**—Brittle first bond heel breaks in AlSi wire have been observed on 68 lead cerquad flat packs at two assembly houses. These low pull strengths of 0.1–2.5 g (annealed) all have the same appearance. 1500x SEM photographs of the fractured surfaces after pull testing all show a grainy brittle structure above and below a center ductile line (Fig. 5). These brittle heel cracks start at the bottom of the heel and can be observed before wire pull. Bottom brittle first bond cracks have not been reported to date.

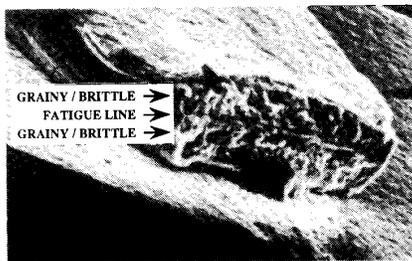
Bottom die heel cracks had not previously been reported [2]. All of the low pull break areas had a grainy structure and a fine horizontal ductile line through the middle without any apparent elongation (Fig. 5).

Fig. 5. Brittle die heel break.

The wires with low pull strengths (< 2.5 g) were all observed to have the same appearance at the die heel fracture on the first bond. They all had a brittle grainy structure with a thin horizontal middle line (Fig. 5). In contrast, the normal pulls had a shiny ductile surface with good taffy-like elongation (Fig. 6).

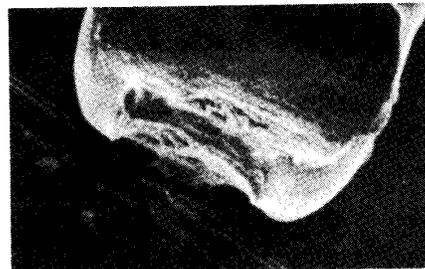
Fig. 6. Normal ductile die heel break.

ductile, elongated, and shiny appearance with no center line (Fig. 6).

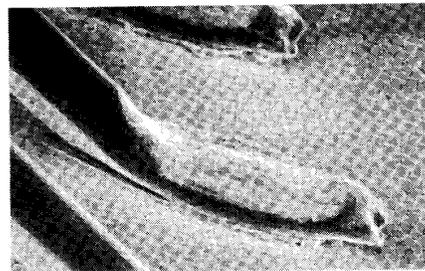
Fig. 7 shows no cracking top or bottom as bonded. This wire was bonded with a very low loop height and low ultrasonics to minimize the typical top heel crack. Fig. 8

Fig. 7. As bonded.

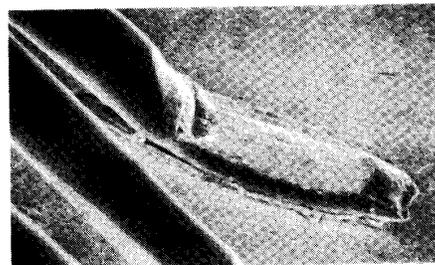
Fig. 8. One 90-deg bend.

shows the typical ductile crack present on AlSi wire in the bond heel area.

This is because under normal bonding conditions, the wire does go through a high amplitude, low frequency excursion during first bond lift off and looping. The second 90-deg bend shows a crack starting at the bottom of the heel (Fig. 9).

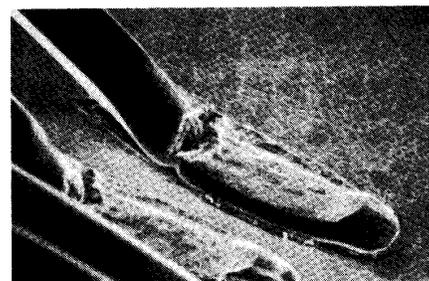
Fig. 9. After the second 90-deg bend.

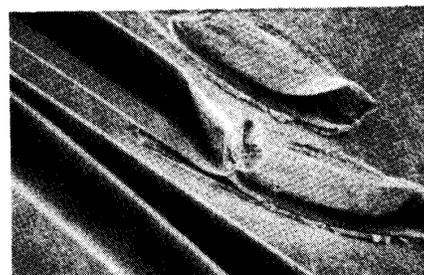
Fig. 10. After the third 90-deg bend.

The third bend shows the two cracks coming together (Fig. 10) and during the fourth bend the wire broke, leaving a horizontal line through the middle of the first bond fractured area, similar to the problem breaks.

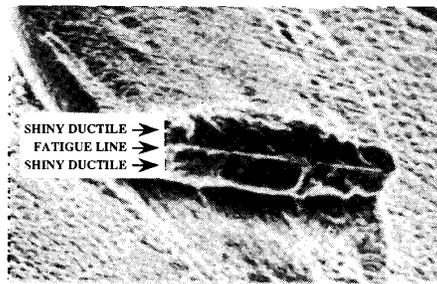
Fig. 11.

The fractured surface, however, did not have the grainy surface, but was shiny with no elongation. This "paper clip" (breaking of a wire by bending) test suggests that these fractures were a fatigue type failure.

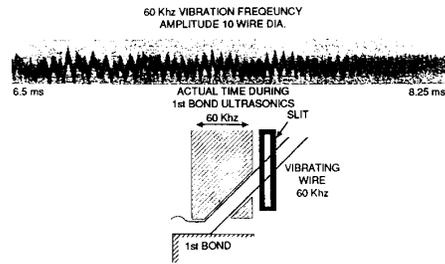
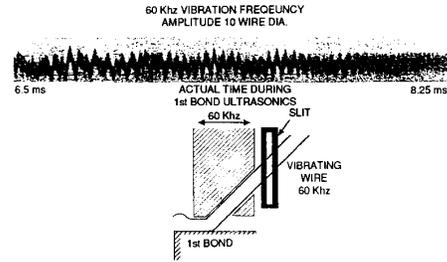
Fig. 15. Vibration on wire at the heel of the first bond during ultrasonics of the first bond.

The streak plot in Fig. 15 illustrates the very high amplitude wire motion (approximately 10 wire diameters) which occurs behind the tool during the application of the first bond ultrasonic energy.

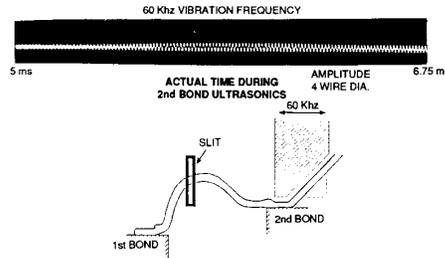
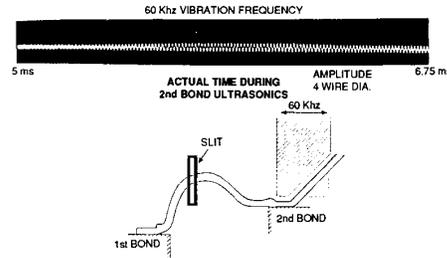
Fig. 16. Vibration on wire near the heel of the first bond as the second bond ultrasonic is being applied.

Fig. 16 is illustrative of the 60-kHz vibration having an amplitude of approximately 4 wire diameters in the vertical direction which is observed all along the wire during the second bond.

No vibration nodes were found along the wire. The vibrations can be found quite close to the heel. The vibrations during the first and second bond are considered the major contributing factors in brittle heel breaks.
