BRITTLE CRACKS INDUCED IN AlSi WIRE BY THE ULTRASONIC BONDING TOOL

R.T Fitzsimmons
Raytheon Company
Route 20, M/S 5-2-467
Sudbury, MA 01776

C.E. Miller
4-409 MIT
Cambridge, MA 02139

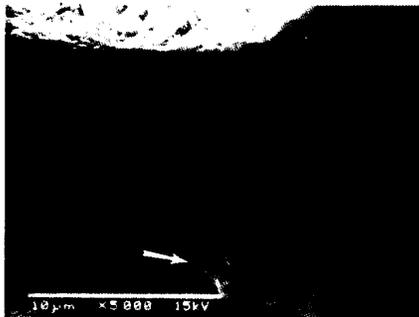
.5 mil CRACK
FIGURE 2

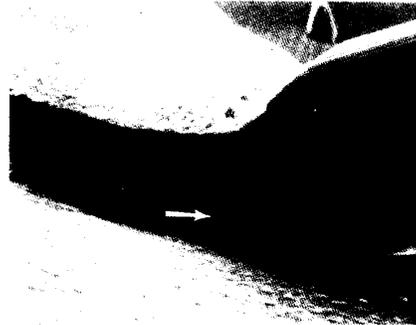
.3 mil CRACK
FIGURE 3

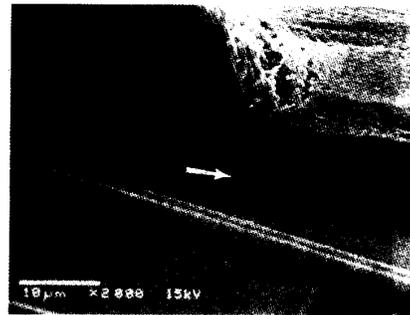
CRACK STARTING
FIGURE 4

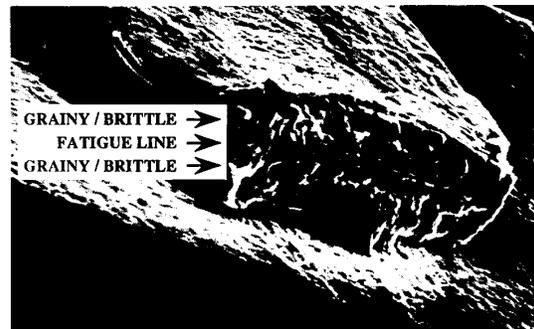
Bottom die heel cracks had not previously been reported. All of the low pull break areas had a grainy structure and a fine horizontal ductile line through the middle without any apparent elongation (Figure 5).

BRITTLE DIE HEEL BREAK
FIGURE 5

The wires with low pull strengths (< 1.0 g) were all observed to have the same appearance at the die heel fracture on the 1st bond. They all had a brittle grainy structure with a thin horizontal middle line (Figure 5). In contrast, the normal pulls had a shiny ductile surface with good taffy-like elongation (Figure 6).

machine models, with wire from 4 different vendors, and has involved approximately 6 bonding wedges. The only way to determine if the problem is present is to SEM the heel areas looking for the brittle structure on the first bond after wire pull (shown in Figure 5).

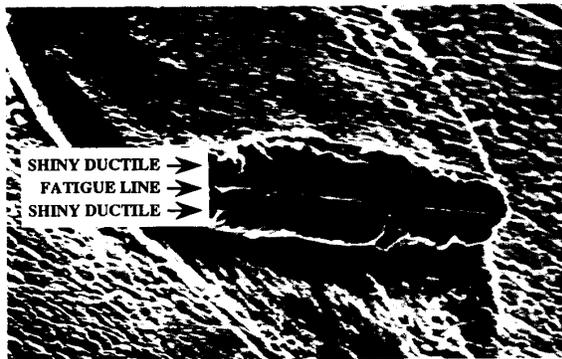
FIGURE 11

The fractured surface, however, did not have the grainy surface, but was shiny with no elongation. This "paper clip test" showed that these fractures were a fatigue type failure.

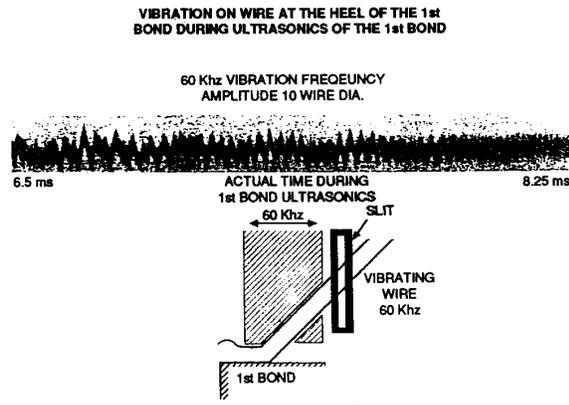
FIGURE 15

The streak plot in Figure 15 illustrates the very high amplitude wire motion (approximately 10 wire diameters) which occurs behind the tool during the application of the first bond ultrasonic energy.

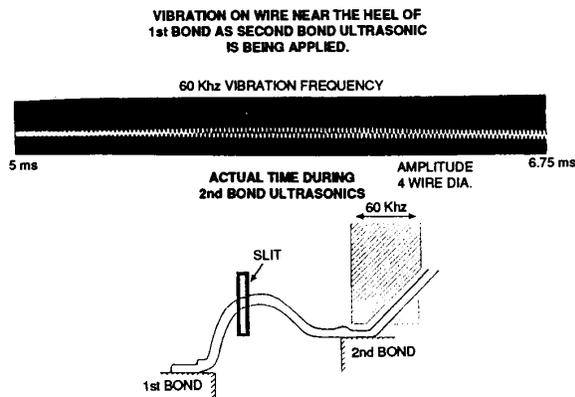
FIGURE 16

Figure 16 is illustrative of the 60 kHz vibration having an amplitude of approximately 4 wire diameters in the vertical direction which is observed all along the wire.

No vibration nodes were found along the wire. The vibrations can be found quite close to the heel. The vibrations during the first and second bond are considered the major contributing factors in brittle die heel breaks.

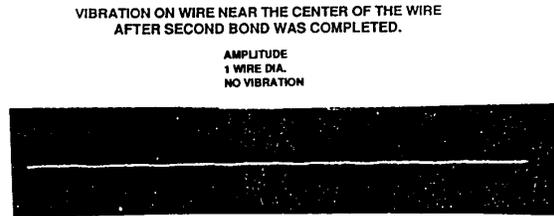
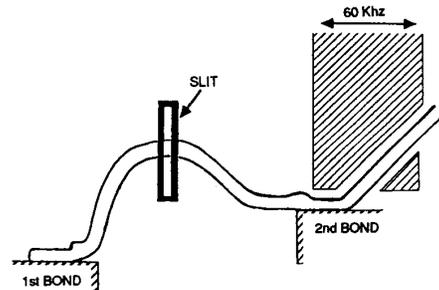
FIGURE 17

The record in Figure 17 illustrates that no 60 kHz energy is present on the wire, or applied to the die heel, when the wire is suitably decoupled from the bond ultrasonics.

The wire demonstrates this same decoupling when adjacent wires are bonded, another indication that only 60 kHz during bonding produces the first bond embrittlement.
