## Recommendations from the Silicon Group for the operation of the CDF Silicon detector in the near future

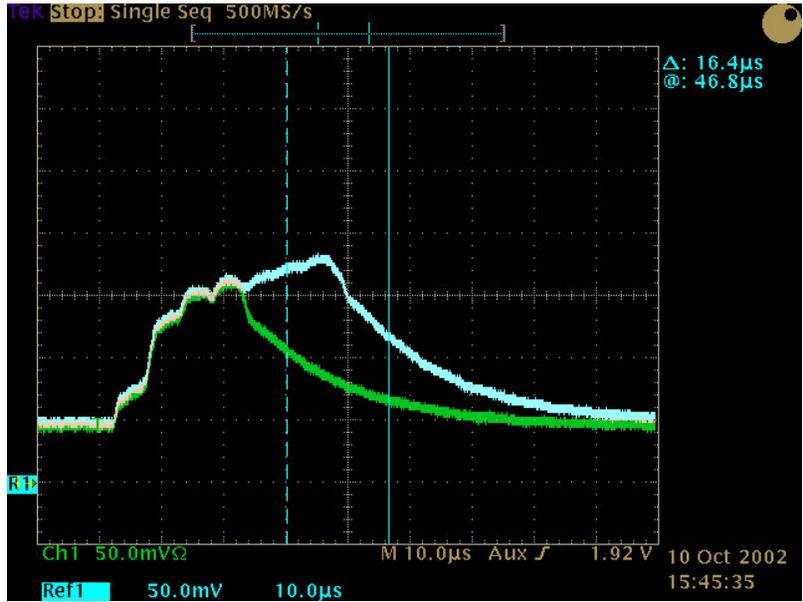
The current consumption through the DVDD jumper connection is reduced by more than 60 % once the new bitstream is downloaded.

Figure 1 DVDD current versus time for a layer 1 ladder in read-all mode. The light gray trace is the current consumption when all 6 chips (3 PHI and 3 Z) are read out while the green trace is the current consumption when only the 3 PHI chips are readout.

While this is hard for the DOIM it can easily be accomplished for the DVDD jumper by not reading out the Z information from SVXII ladders. This can be done without any hardware change but only by downloading a new bitstream of settings to the SVX3d chips in the SVX2 detector.

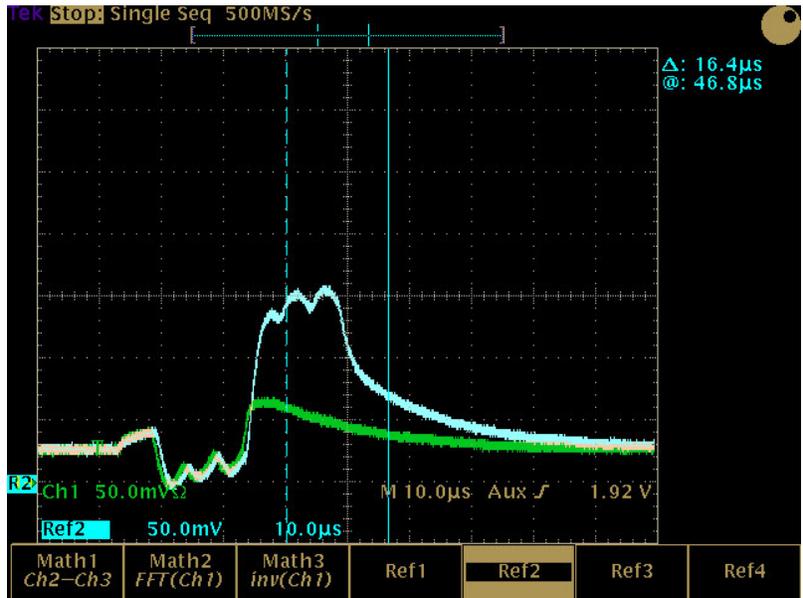
Figure 2 DVDD current versus time for a layer 1 ladder in read-all mode. The current is now measured through the replaced jumper connection. The light gray trace is the current consumption when all 6 chips are read out while the green trace is the current consumption when only the 3 PHI chips are readout.
