*M. Binkley, R. Madrak, K. Burkett, R. W. Wagner,*

On July 15 and July 16, 2004 several wire samples were taken to the TD SEM in IB3. Donna Hicks and Deepak Chichili operated the equipment. On August 6, 2004 a follow up study was done with Donna to check some of the measurements and to look at an aged wire in the region of the center support.

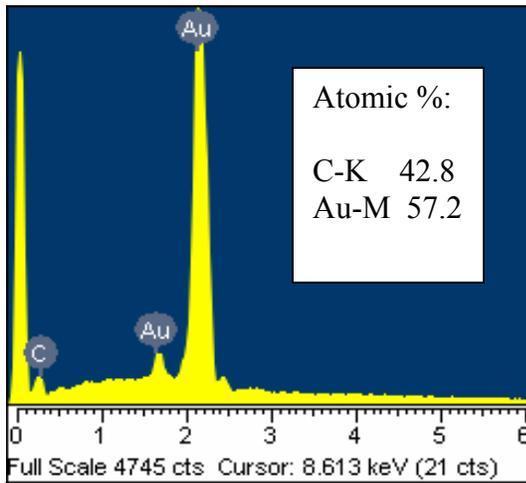
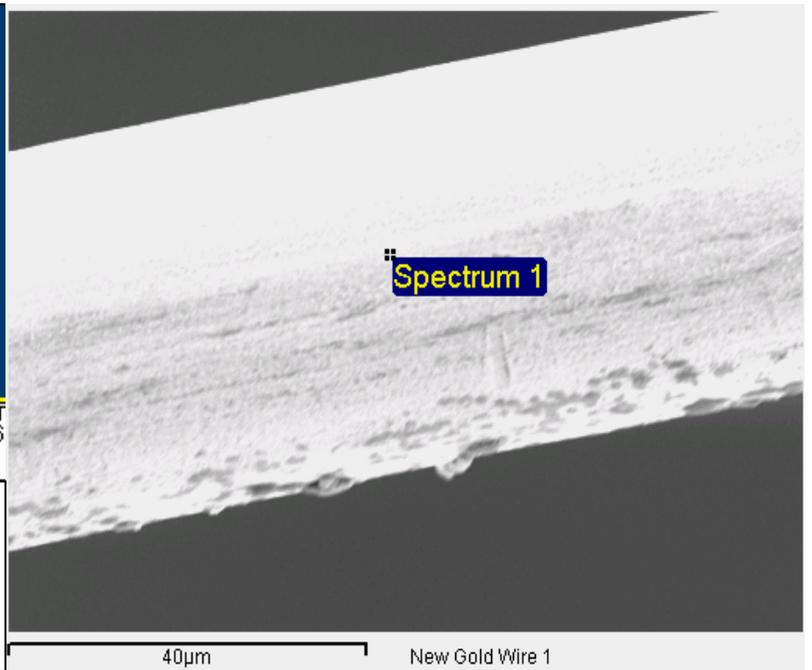
### New wire measured in July

EDS analysis of a new wire directly from the spool. The surface appears bright. Mostly gold is seen; the carbon is appears to be background.

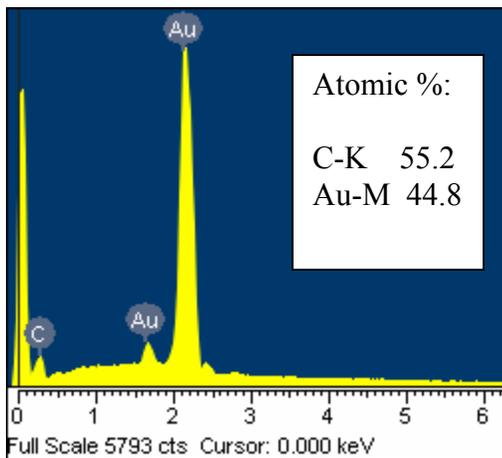
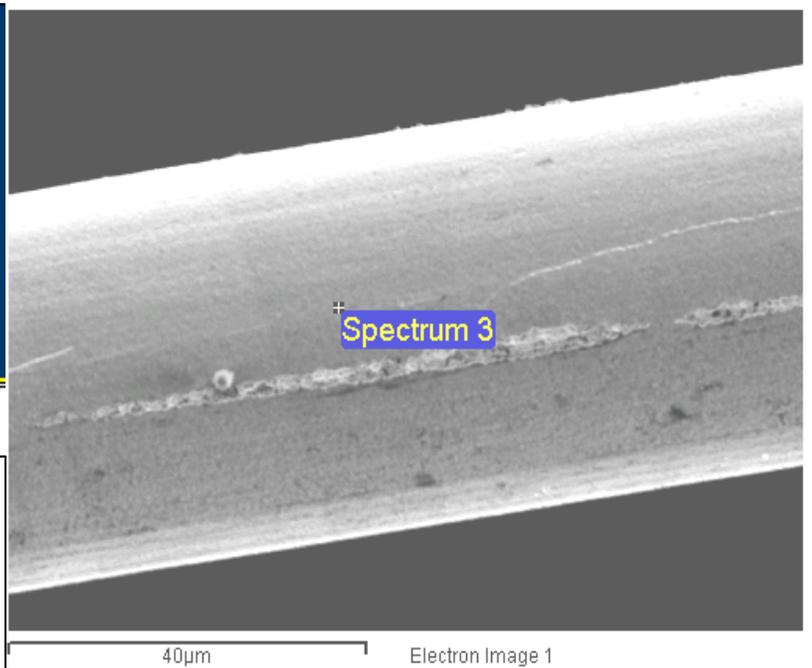
### New wire measured in August

EDS analysis repeat in August of the same piece of new wire analyzed above in July. Similar results are seen: roughly 50% carbon and 50% gold.

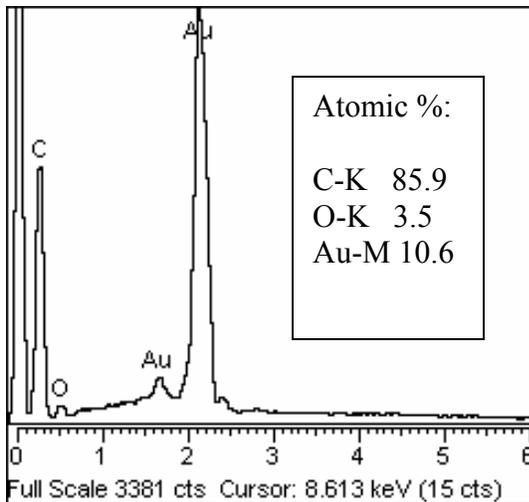
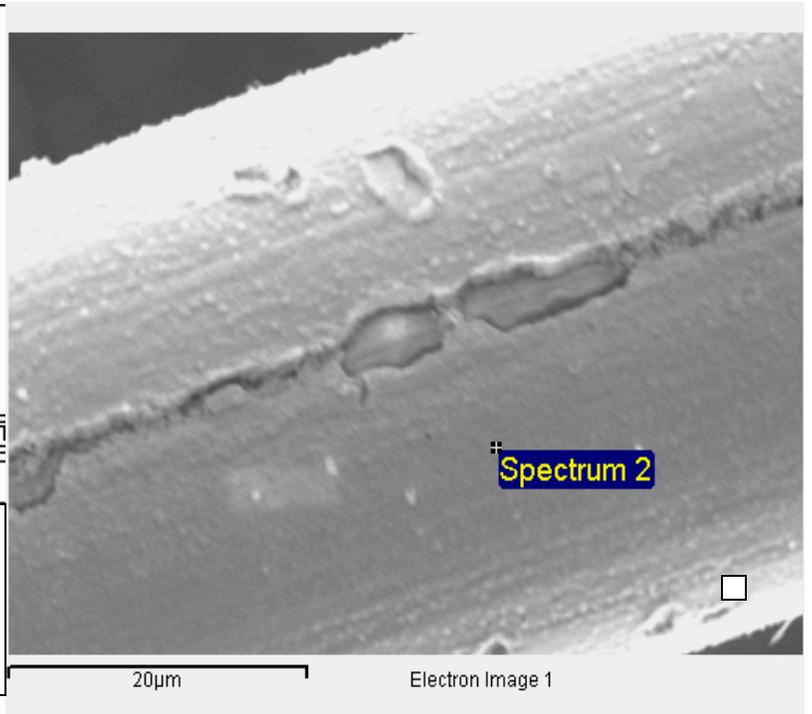
## Aged Wire directly from COT--general area in July

EDS analysis of the aged wire near the center in a general area. The surface is duller. Mostly carbon with a little gold and oxygen are seen.

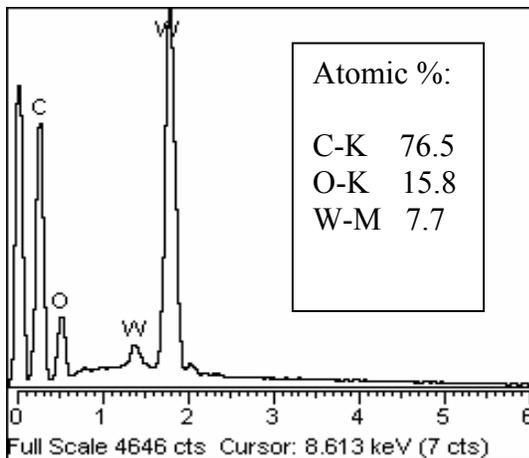
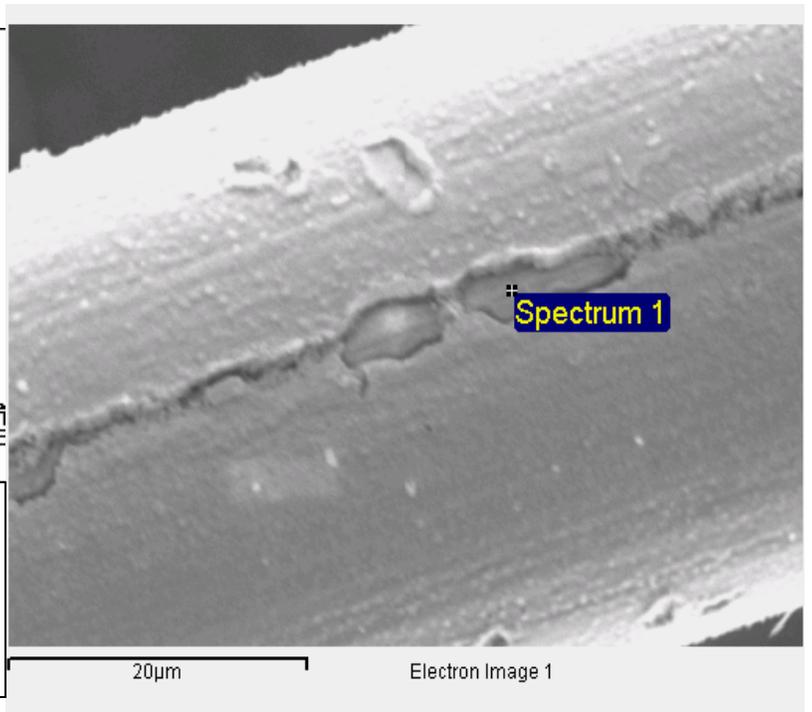
## Aged wire directly from COT--crater in July

EDS analysis of a crater near the center of the aged wire. Tungsten is seen instead of gold. The carbon polymer coating is still seen. Also the oxygen level is high (WO?).

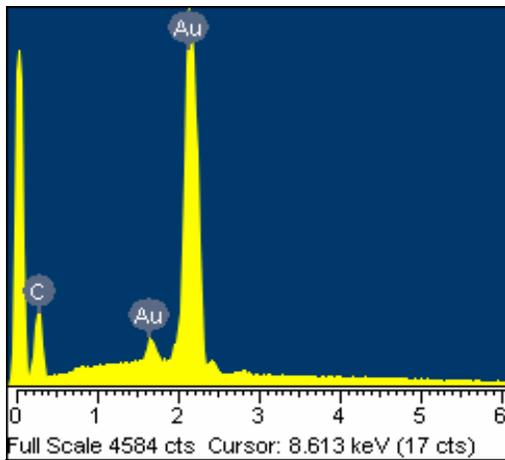
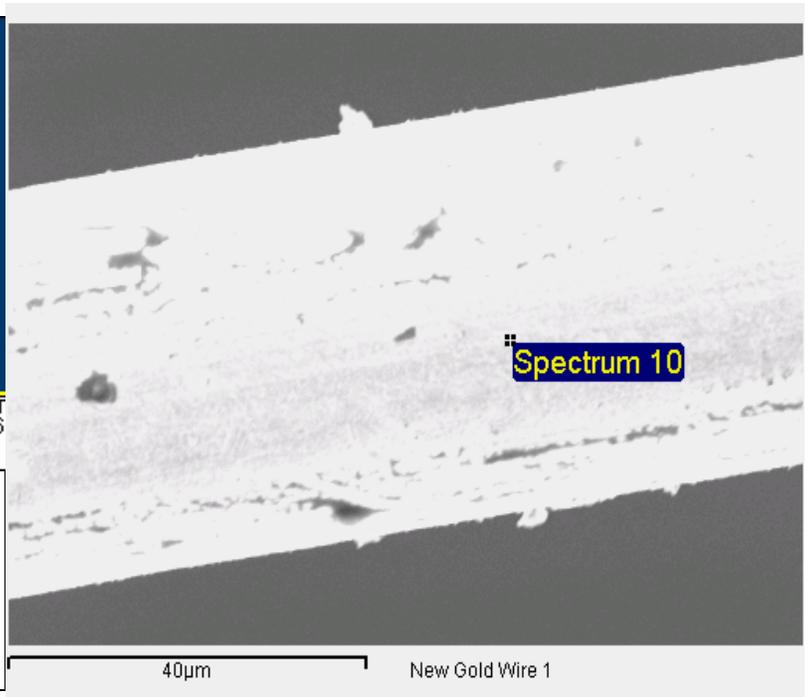
### Reverse aged in SS tube in COT exhaust gas--at center in July

EDS analysis of the wire reverse aged in SS tube with COT chamber exhaust. Wire surface looks brighter than age wire, but more carbon seen than on new wire.

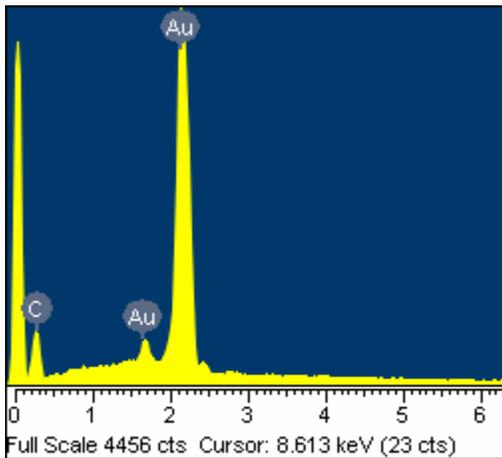
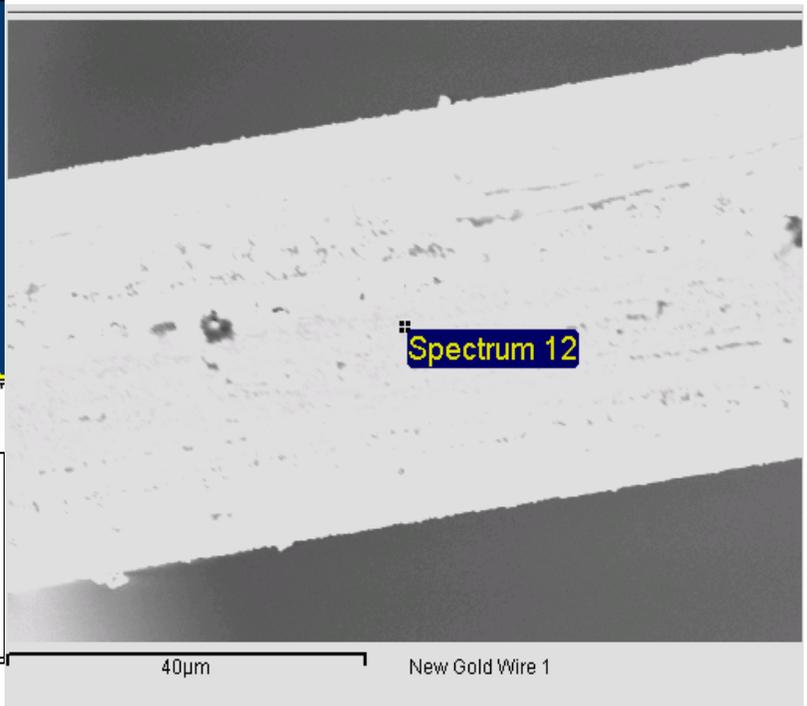
### Reverse aged in SS tube in COT exhaust gas--6mm to right in July

EDS analysis of the wire reverse aged in the SS tube chamber with COT exhaust gas. Wire surface looks brighter than aged wire, but more carbon than new wire.

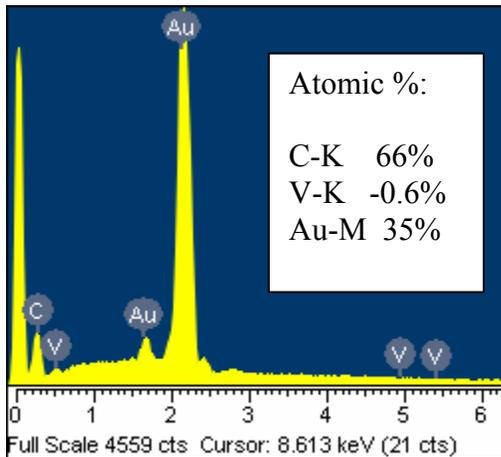
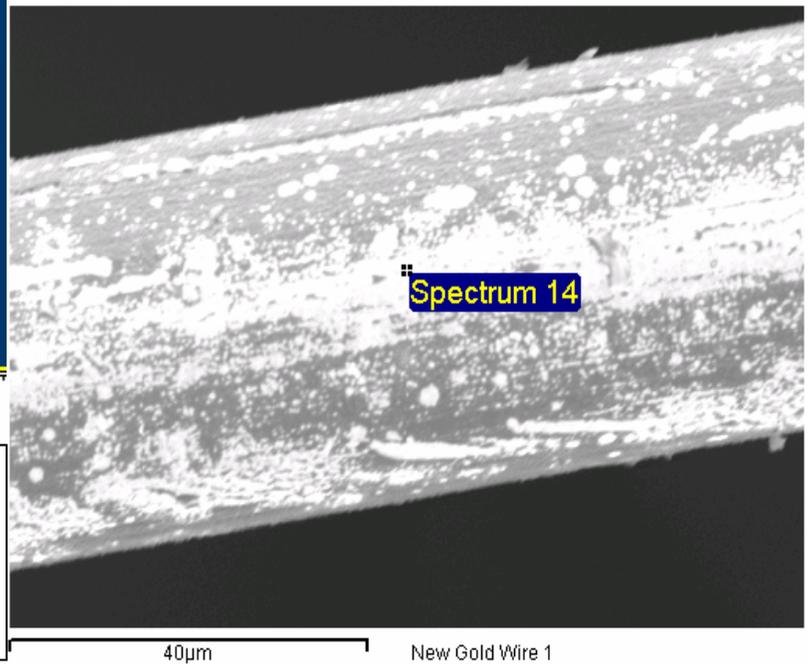
## Reverse aged in SS tube in COT exhaust--20mm to right in July

EDS analysis of the wire reverse aged in the SS tube 20mm from the center. There are bright and dark areas on the surface. Analysis of the bright area shows less carbon.

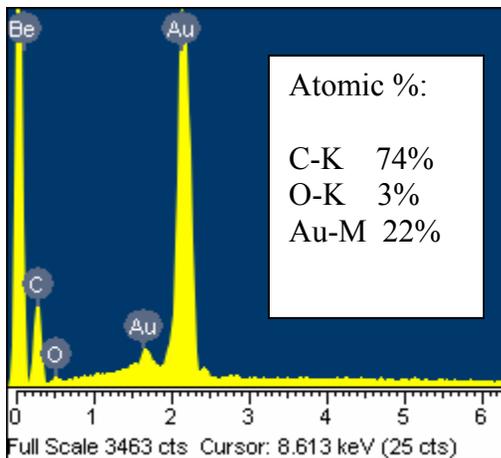
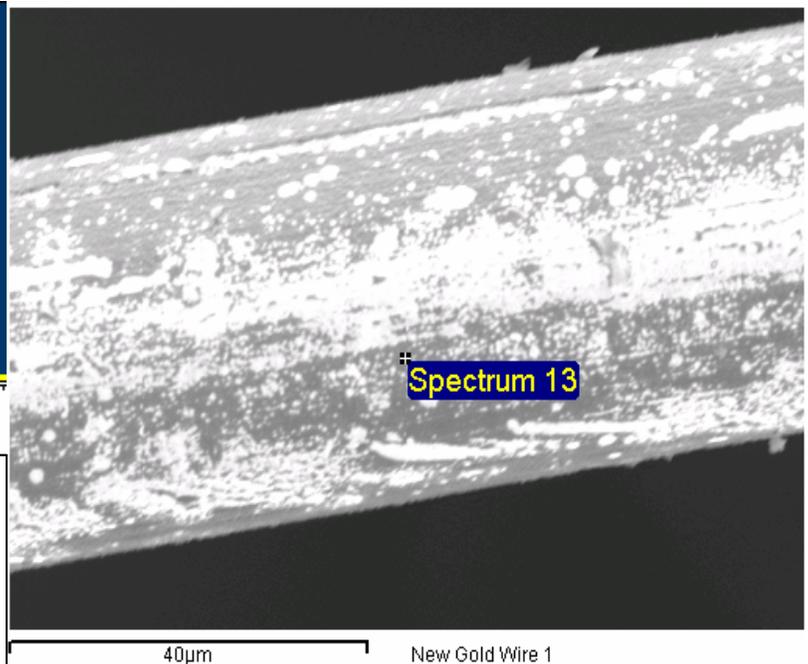
## Reverse aged in SS tube in COT exhaust gas 20mm to right in July

EDS analysis of the wire reverse aged in the SS tube 20mm from the center. The bright areas have been reverse aged more. The analysis of the dark area shows more carbon.

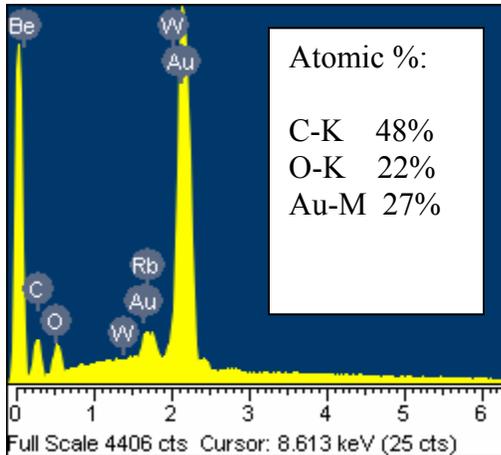
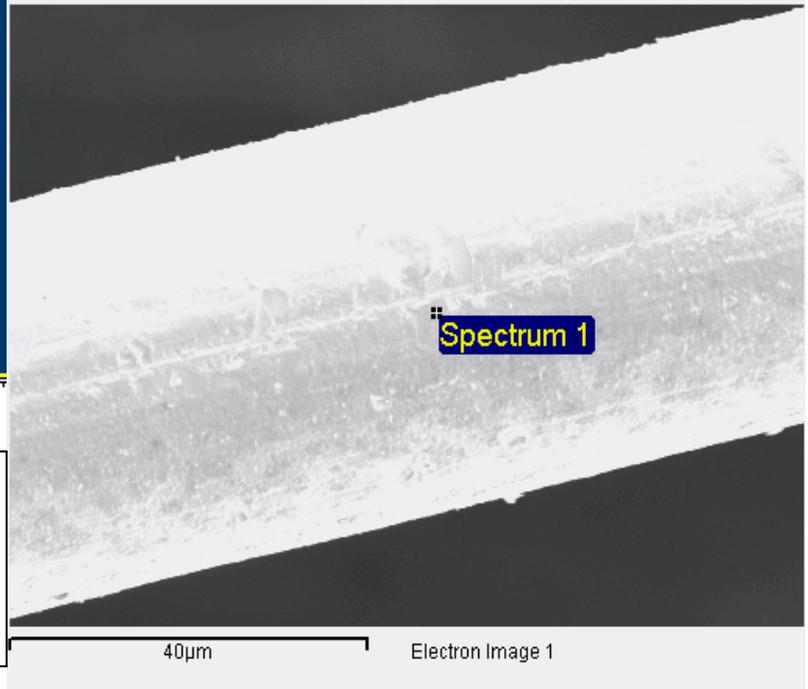
### GMC wire reverse age in Ar/CO2 at the center (avg2) in July

EDS analysis of the wire reverse aged in the GMC (Ar/CO2) at the center. The surface is bright and the carbon level is relatively low, but the oxygen level is higher.

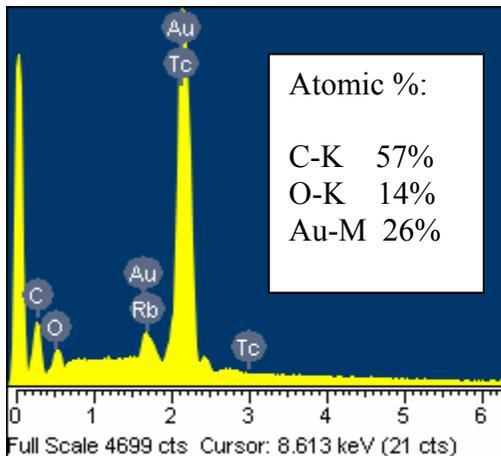
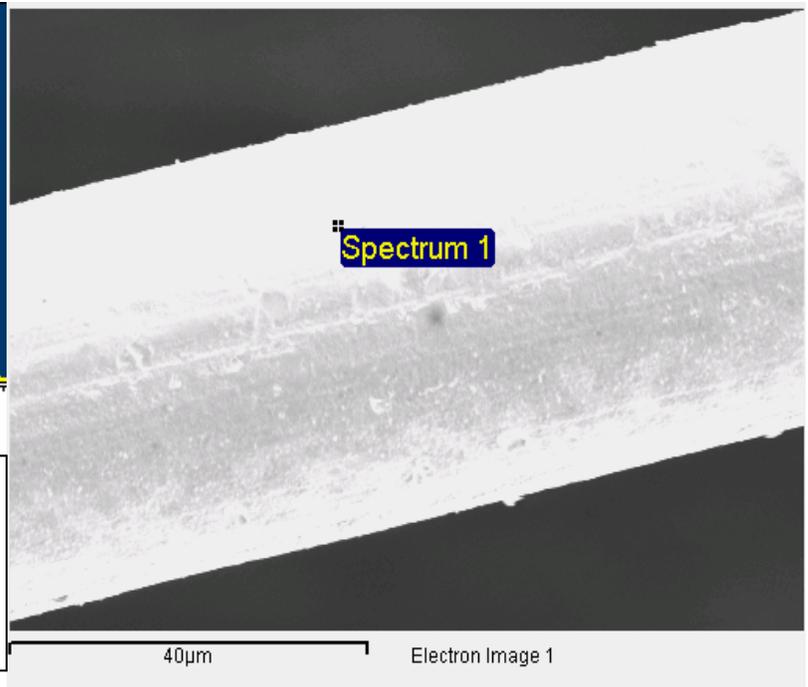
### GMC wire reverse aged in Ar/CO2 at the center (avg3) in July

EDS analysis of the wire reverse aged in the GMC (Ar/CO2) at the center. Similar to above, but a little less oxygen. Possible traces of Rb and Tc at the 1% level.

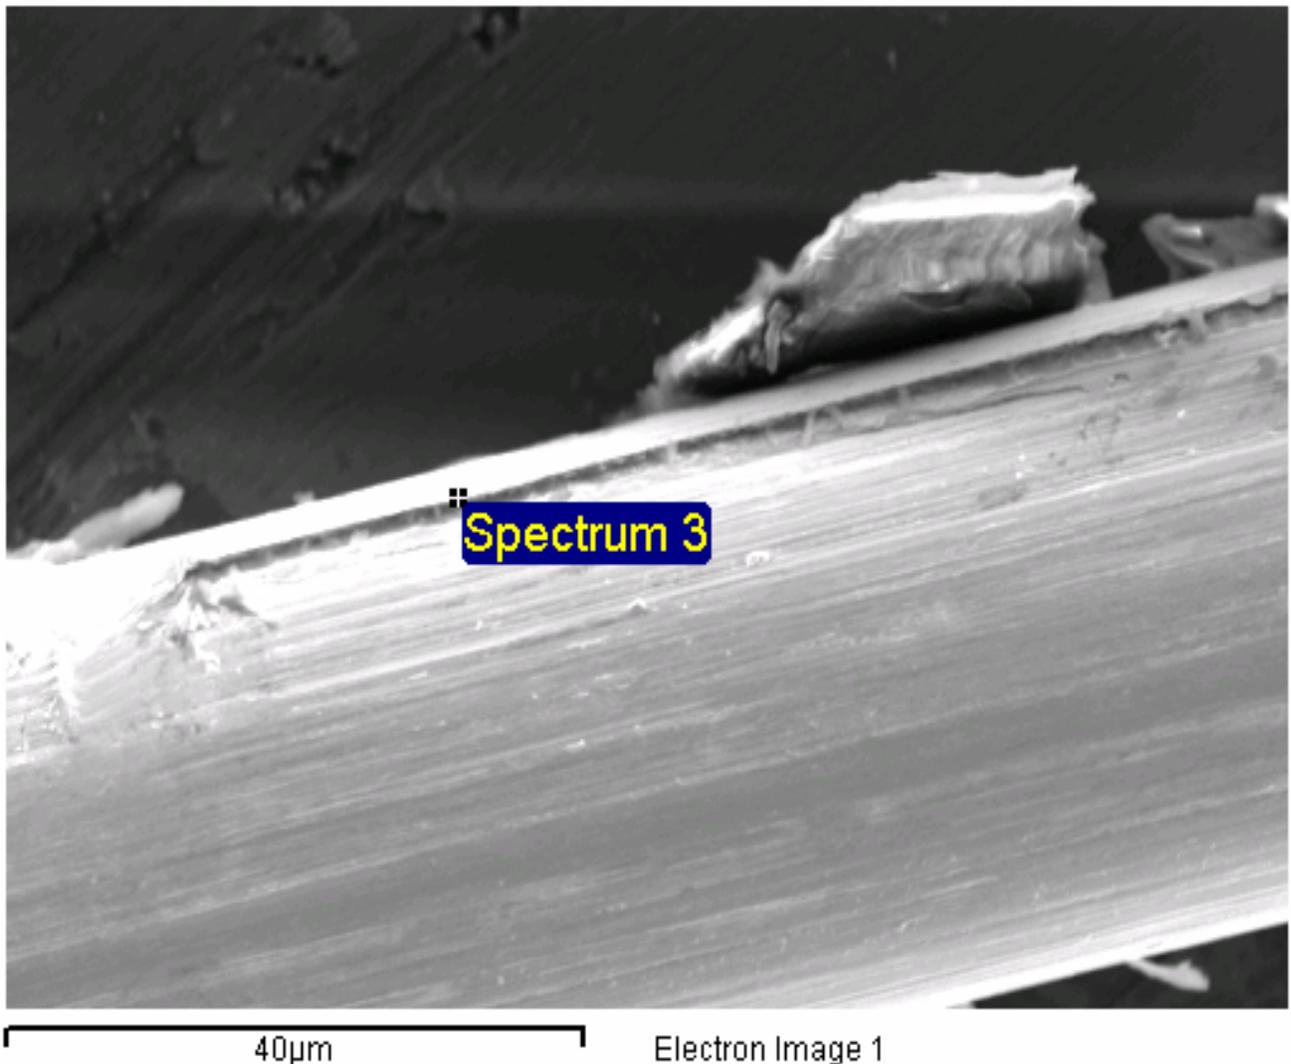
The following picture taken in July shows a piece of the aged wire that had been scrapped to remove some of the coating. The upper right hand side of the pictures shows a fairly clear edge of the coating. Underneath the dark coating is a bright line that is presumably the gold coating. Typically when the wire has been scrapped, the gold comes off with the coating. The last EDS analysis shown above is an example of that. The scale on the picture is given by both the scale on the lower left and the diameter of the wire, both of which are 40 microns. Using this to scale the thickness of the coating gives about 1.7 microns. The thickness of the gold is consistent with the expected 0.3 microns (5% gold by weight).
