# Brittle Cracks Induced in AlSi Wire by the Ultrasonic Bonding Tool Vibration

Raymond T. Fitzsimmons and C. E. Miller

**Abstract**—Brittle first bond heel breaks in AlSi wire have been observed on 68 lead cerquad flat packs at two assembly houses. These low pull strengths of 0.1–2.5 g (annealed) all have the same appearance. 1500x SEM photographs of the fractured surfaces after pull testing all show a grainy brittle structure above and below a center ductile line (Fig. 5). These brittle heel cracks start at the bottom of the heel and can be observed before wire pull. Bottom brittle first bond cracks have not been reported to date.

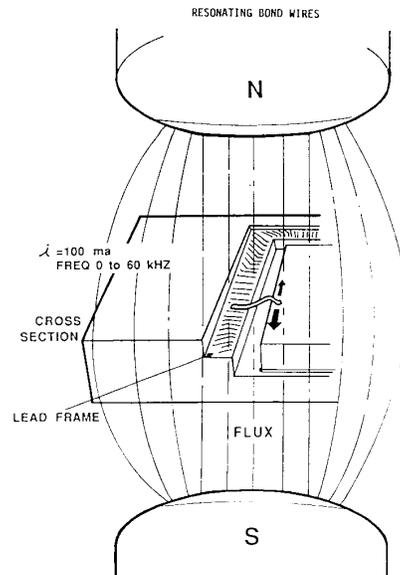
In order to reproduce the grainy structure and to determine the resonant frequency of the wires, each of the wires in the package was resonated as illustrated in Fig. 12.

A fixed alternating current of 100 MA was passed through the wires over the frequency range of 5–100 kHz. The envelope of mechanical vibrations were observed visually when resonance occurred. Resonant vibrations were found only in the range of approximately 10–15 kHz, depending upon wire length. During the test, several wires fractured, and SEM photographs of their break areas exhibited a grainy fractured surface similar to the structure in the problem wires. These results suggest that low bond pulls were the result of a high frequency, low amplitude fatigue type failure.

Fig. 12. Material-Al 1% Si. Diameter-0.00125 Height-0.015 in. Length-0.110. Resonance-14 kHz.
