BRITTLE CRACKS INDUCED IN AlSi WIRE BY THE ULTRASONIC BONDING TOOL

R.T Fitzsimmons
Raytheon Company
Route 20, M/S 5-2-467
Sudbury, MA 01776

C.E. Miller
4-409 MIT
Cambridge, MA 02139

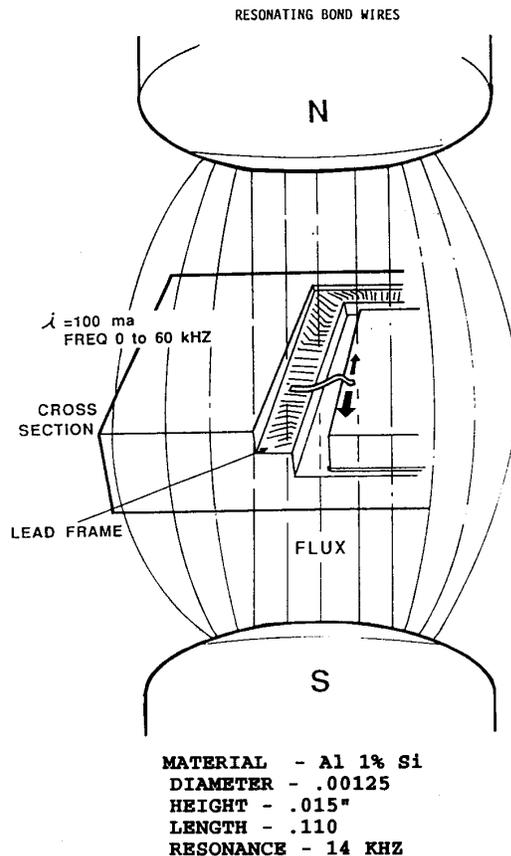
FIGURE 12

In order to reproduce the grainy structure and to determine the resonant frequency of the wires, each of the wires in the package was resonated as illustrated in Figure 12.

A fixed alternating current of 100 mA was passed through the wires over the frequency range of 5 to 100 kHz. The envelope

of mechanical vibrations visually were observed when resonance occurred. Resonant vibrations were found only in the range of approximately 14 +/- 2 kHz, depending upon wire length. During the test, several wires fractured, and SEM photographs of their break areas exhibited a grainy fractured surface similar to the structure in the problem wires. These results show that low bond pulls were the result of a high frequency, low amplitude fatigue type failure.

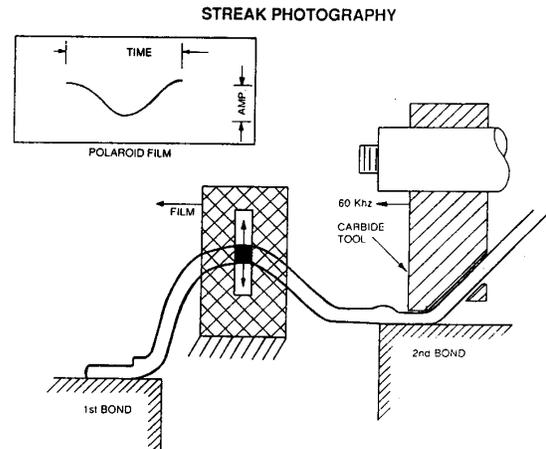
FIGURE 13

To understand the technique of streak photographic recording, consider that the film in a conventional camera (Figure 13) "sees" only a single point of interest along the length of the wire through a narrow slit.

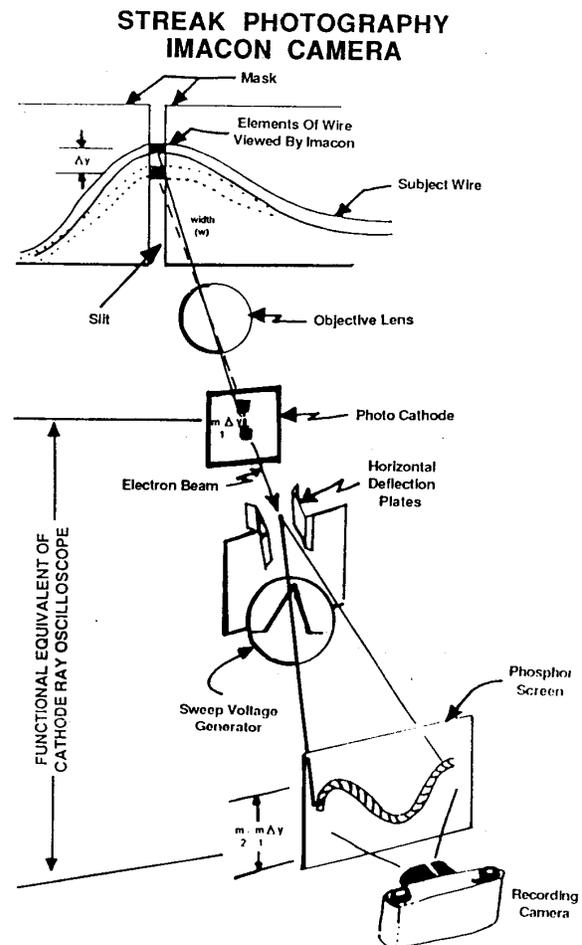
FIGURE 14

Figure 14 is a schematic diagram illustrating how the IC camera makes a streak recording.
