*M. Binkley, R. Madrak, K. Burkett, R. W. Wagner,*

On July 15 and July 16, 2004 several wire samples were taken to the TD SEM in IB3. Donna Hicks and Deepak Chichili operated the equipment. On August 6, 2004 a follow up study was done with Donna to check some of the measurements and to look at an aged wire in the region of the center support.

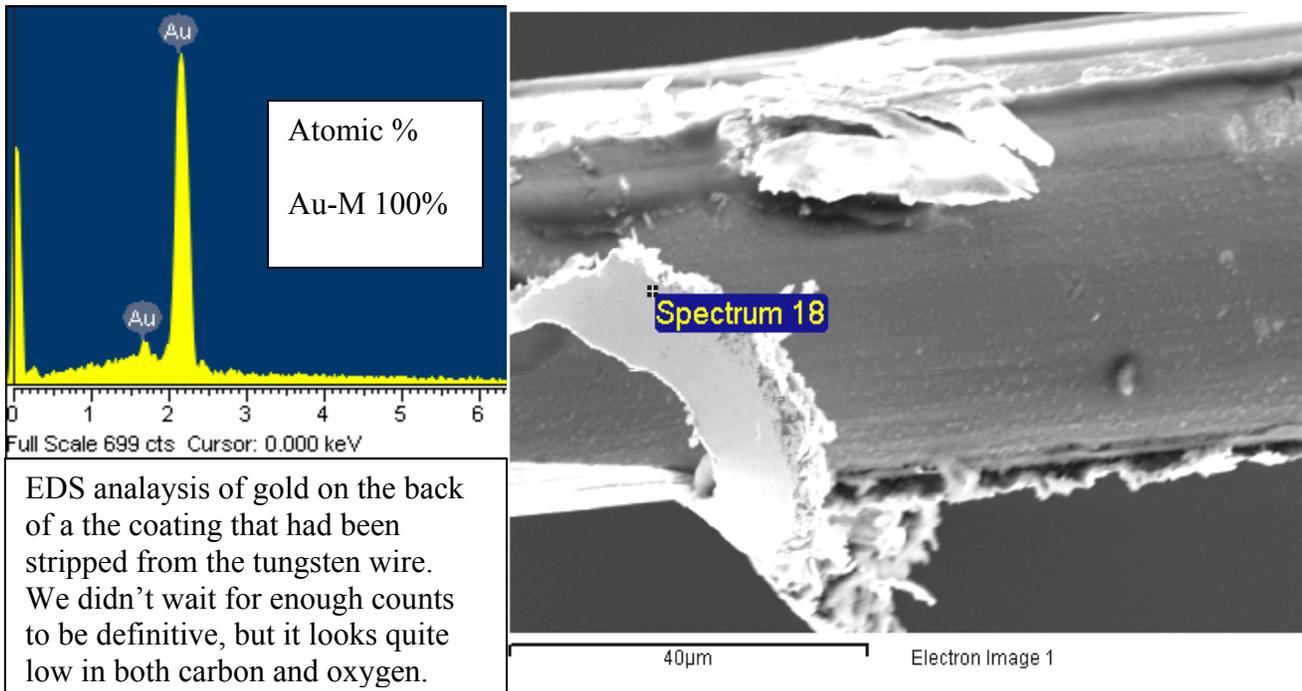
## Aged wire from the COT that had been scrapped – in August

The following picture taken in July shows a piece of the aged wire that had been scrapped to remove some of the coating. The upper right hand side of the pictures shows a fairly clear edge of the coating. Underneath the dark coating is a bright line that is presumably the gold coating. Typically when the wire has been scrapped, the gold comes off with the coating. The last EDS analysis shown above is an example of that. The scale on the picture is given by both the scale on the lower left and the diameter of the wire, both of which are 40 microns. Using this to scale the thickness of the coating gives about 1.7 microns. The thickness of the gold is consistent with the expected 0.3 microns (5% gold by weight).
